SRE FUEL ELEMENT DAMAGE

FINAL REPORT

SRE FUEL ELEMENT DAMAGE
FINAL REPORT

CONTRACT: AT(11-1)-GEN-8
ISSUED: JUN 30 1961

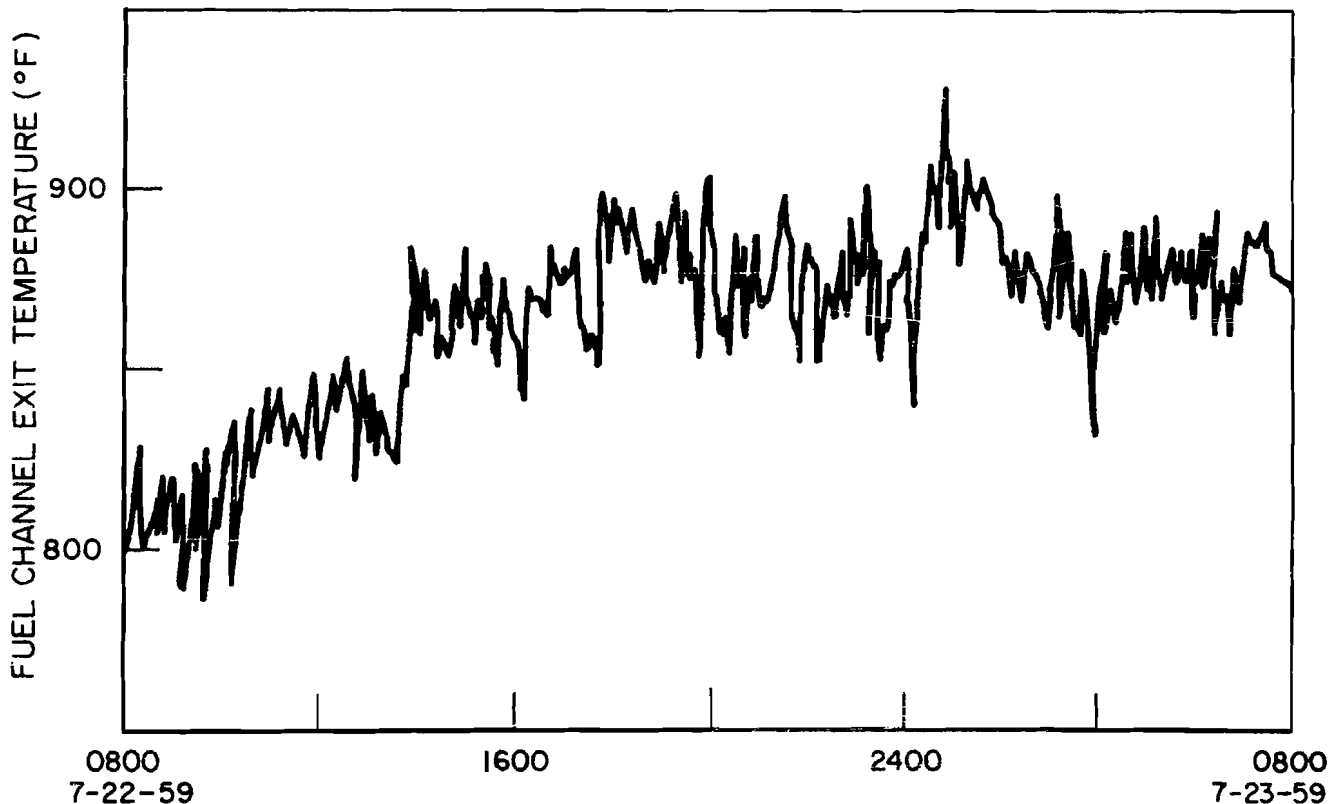
Figure III-5. Outlet Temperature for Channel R-24

A careful review of the chart from run 14 showed that all of the channels in which fuel failures occurred had shown fluctuations in outlet channel temperatures. The record of temperatures from channel R-24 for a typical 24-hr period is shown in Figure III-5. Fluctuation in outlet channel temperatures also occurred for a few hours in some channels in which the fuel elements did not fail. The element from R-25, in which temperature fluctuations occurred for only part of the run, suffered the least damage of the thirteen damaged elements. The temperature history for R-25 over a 24-hr period is shown in Figure III-6. Some indication of the relation between fuel temperatures at some regions of the element and the outlet channel temperatures can be gained from the data for R-55
